Radio Propagation Measurements During a Building Collapse: Applications for First Responders

Christopher L. Holloway, Galen Koepke, Dennis Camell, Kate A. Remley, and Dylan Williams

National Institute of Standards and Technology (NIST)
Electromagnetics Division, U.S. Department of Commerce, Boulder Laboratories
325Broadway, Boulder, Colorado 80305, email: holloway@boulder.nist.gov

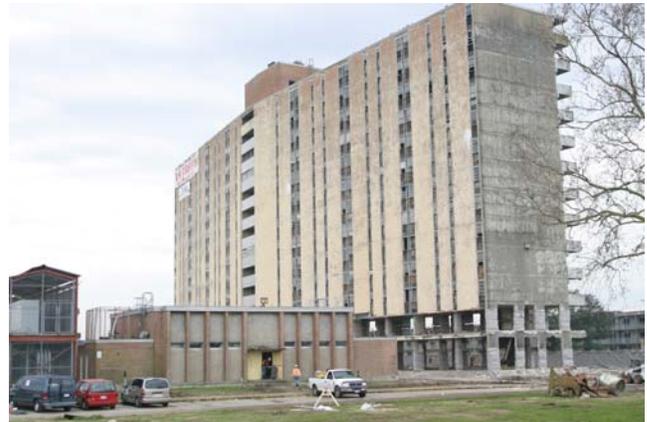
Figure 1: New Orleans apartment building.

This paper discusses one such set of experiments carried out in a 14-story apartment complex near New Orleans, LA (see Figure 1).

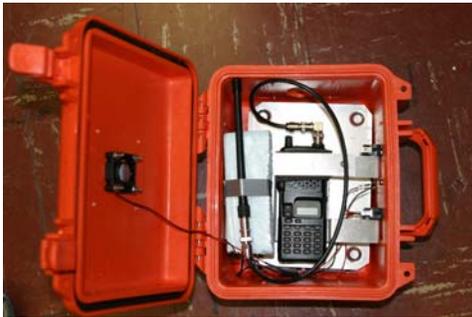
Figure 2: Typical Transmitter.

Two types of data were collected in the experiment. The first set of data, which is referred to as “radio mapping,” was collected a few days before the building was imploded. This involved carrying radios tuned to various frequencies through the building while recording the received signal from a site located outside the building. Figure 2 shows a typical radio

that was used. The radio was placed in a protective case to improve survivability after the implosion.

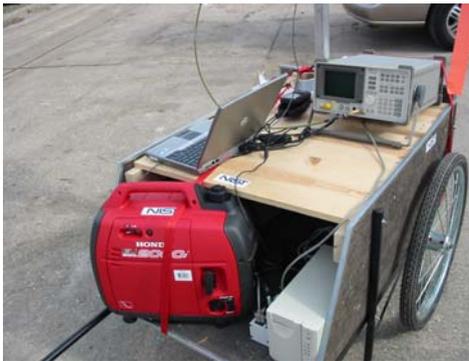
Figure 3: Mobile receiving cart.

In the second type of data collection, radios were placed in fixed sites throughout the building. Received signals were collected before, during, and after the implosion. Our receiving sites in this case were both fixed and mobile. The mobile site consisted of a measurement system placed on a cart (see Figure 3). The cart was pulled around the perimeter of the building both before and after the implosion, enabling direct comparison of signal strength through the building and through rubble.
